# Navajo Abandoned Uranium Mine

# Site Screen Report

## **Tohe Thlany Begay AUM Site**

March 2010

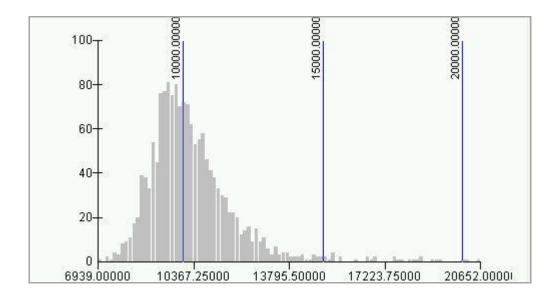
The following chart and statistics were generated by ESRI ArcGIS 9.3.1, and show the general distribution of the site gamma radiation measurements. The horizontal X axis represents the gamma radiation reading levels in cpm (lowest levels to the left). The vertical Y axis represents the frequency of each gamma radiation level.

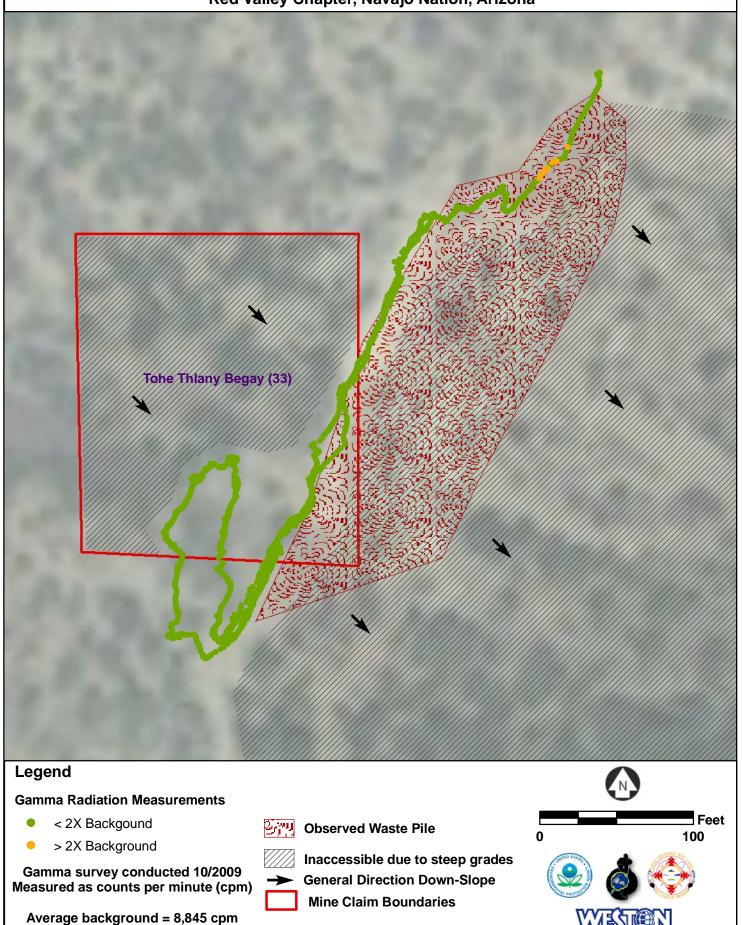
Figure 1 - Gamma Radiation Measurements, Above Two Times Background
Tohe Thlany Begay (33)
Red Valley Chapter, Navajo Nation, Arizona

A total of 1,557 gamma radiation measurements were collected from the mine site, ranging from 6,939 cpm to 20,652 cpm. The measurements are represented in Figures 1 and 2.
